Leon Environmental Services

**Re: Asbestos Survey
Demo House
13544 Road 26 ½
Madera, CA
Job No. S75-23-01**

Asbestos Survey: Demo House, 13544 Road 26 ½, Madera, CA **S75-23-01**

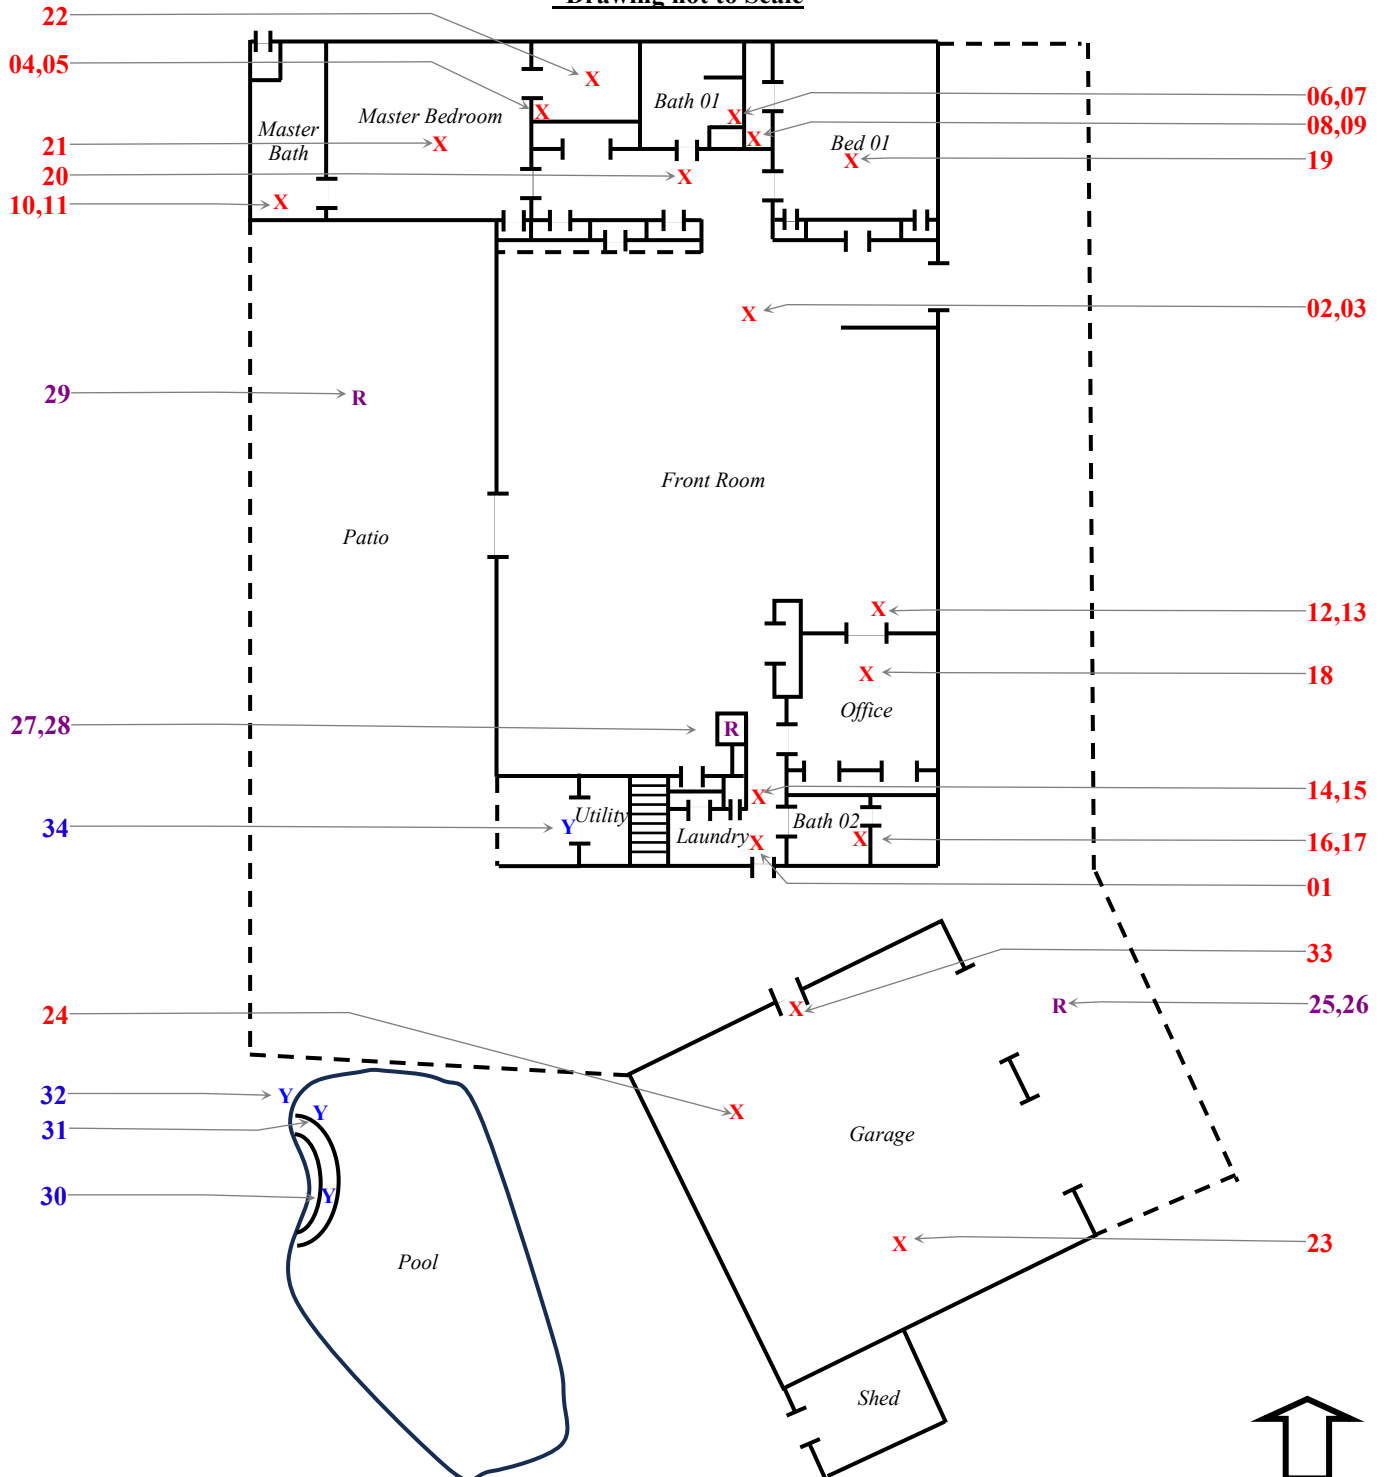
Job S75-23 / Sample Location Diagram
Demo House / 13544 Road 26 ½, Madera, CA
Domingo Mora / Madera Unified School District
Drawing not to Scale

The Linoleum and Adhesive (sample 01) located on the floor in the laundry room, bathroom, and hall, is positive for asbestos at 5%.

These materials are considered ***friable hazardous ACM*** and it is required that a licensed asbestos abatement contractor remove these materials prior to renovation and or demolition of this structure.
