**Re: Asbestos Survey**  
**Demo House & Garage/Shop**  
**13568 Road 26 ½**  
**Madera, CA**  
**Job No. S75-23-02**

## **Asbestos Survey: Demo House, 13568 Road 26 ½, Madera, CA** **S75-23-02**

An asbestos survey was performed on **July 05, 2023** at **13568 Road 26 ½, Madera, CA.**

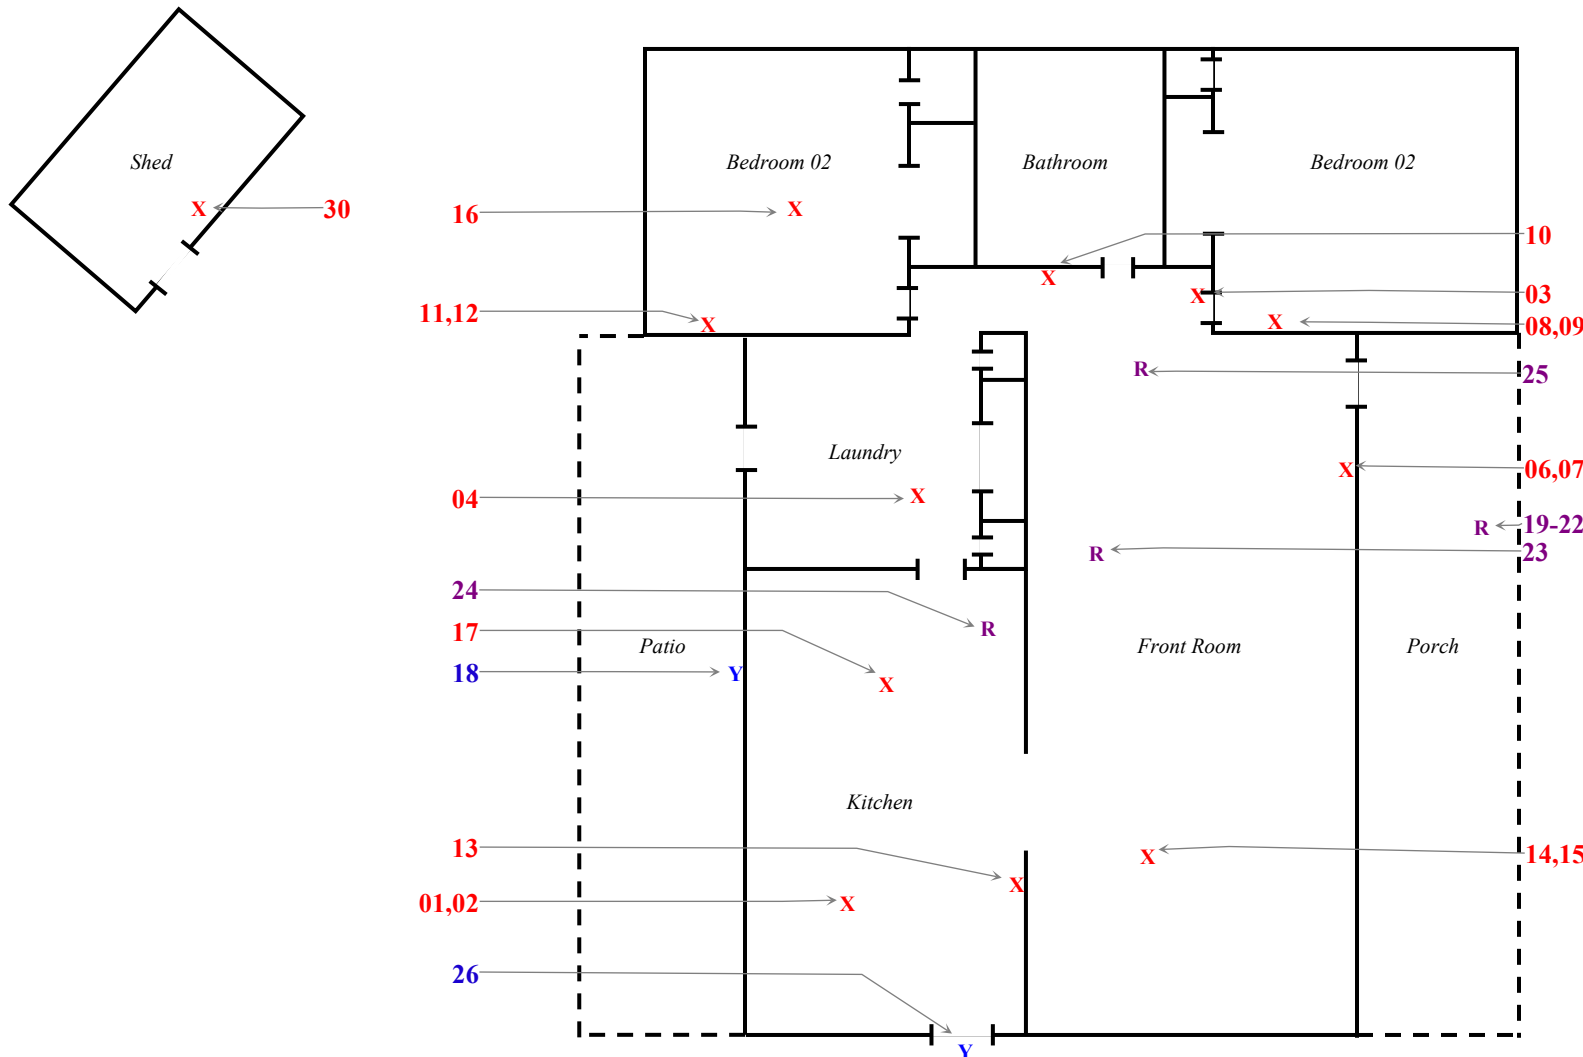
**Job S75-23-02 Sample Location Diagram**  
**Demo House / 13568 Road 26 ½, Madera, CA**  
**Domingo Mora / Madera Unified School District**  
**Drawing not to Scale**

***The Black Mastic*** (sample 02) located under the floor tile In the kitchen (bottom layer) is positive for asbestos at 3%.

**The Linoleum and Adhesive** (samples 01, 04) located on the floor in the kitchen (top layer) and laundry room (top layer) is positive for asbestos at 5%.

These materials are considered a ***non-hazardous non-friable ACM***. It is required that a licensed asbestos abatement contractor remove these materials prior to renovation and or demolition of this structure.

These materials are considered ***friable hazardous ACM*** and it is required that a licensed asbestos abatement contractor remove these materials prior to renovation and or demolition of this structure.
