BID ADDENDUM NO 3

Project: MADERA UNIFIED SCHOOL DISTRICT MADERA HIGH SCHOOL CTE MODERNIZATION DSA FILE#20-H3 DSA APPLICATION #02-116098 19six Architects Project No. 16052.01 MUSD Bid No. 021919

Asbestos and Lead Survey Report

CTE Building Modernization Madera High School 200 South L Street Madera, CA 93637

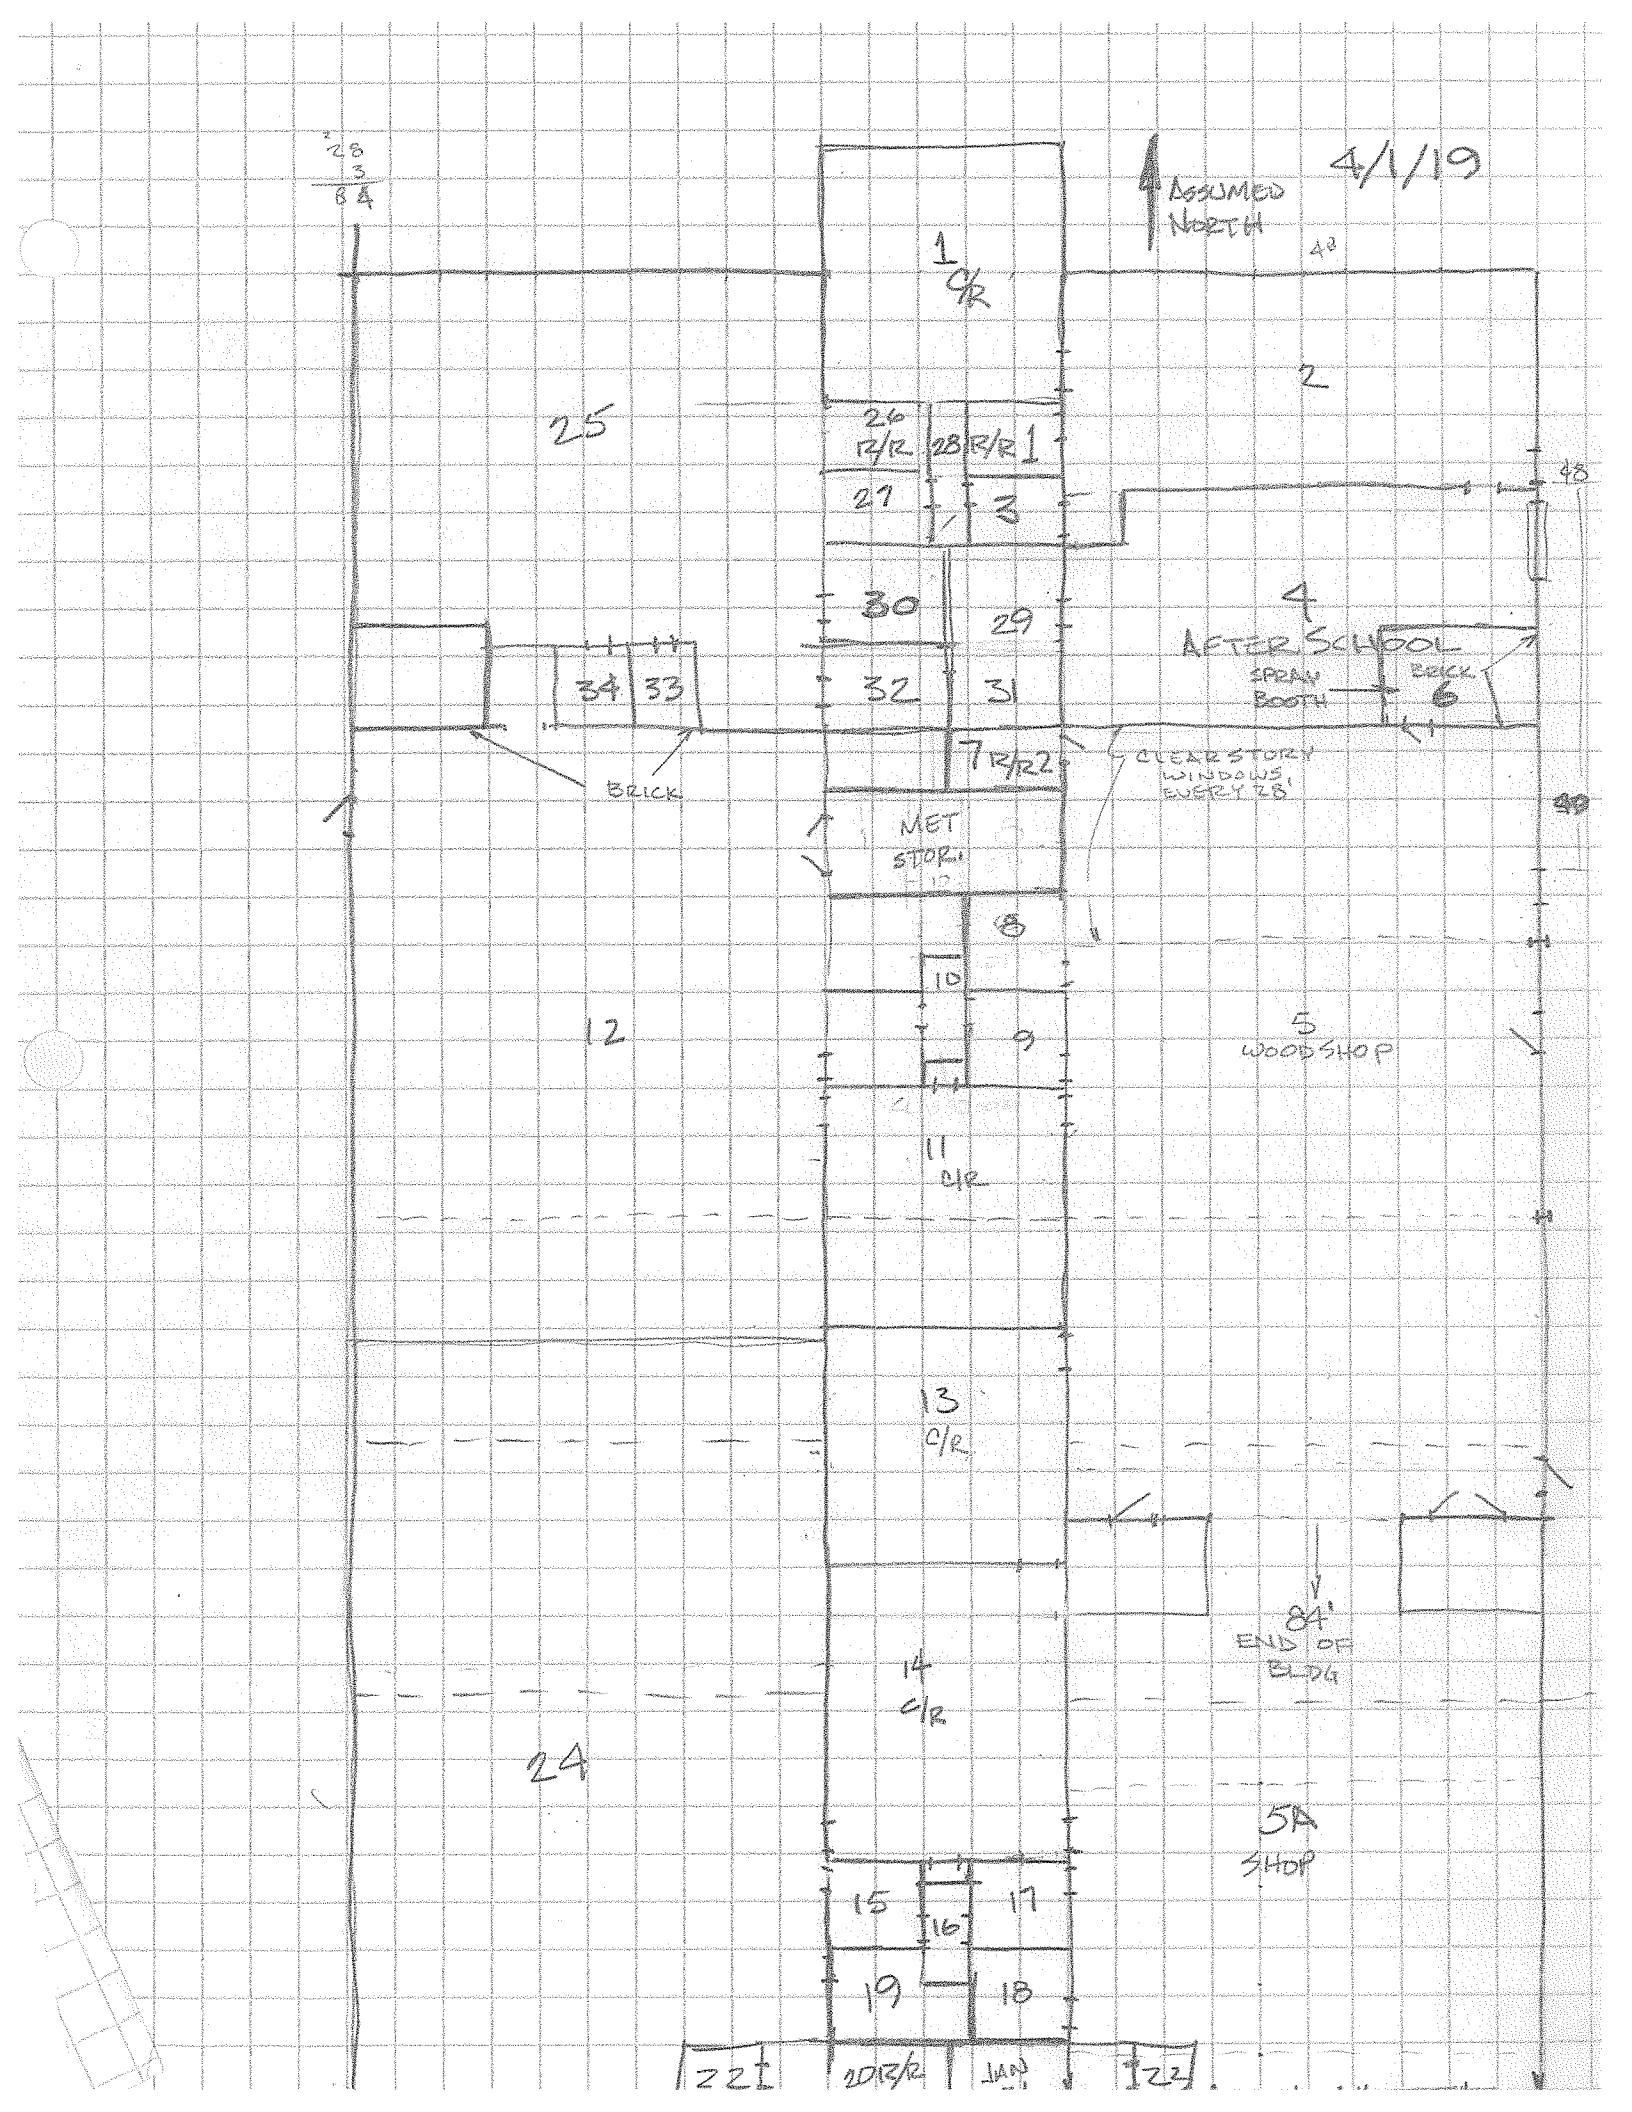
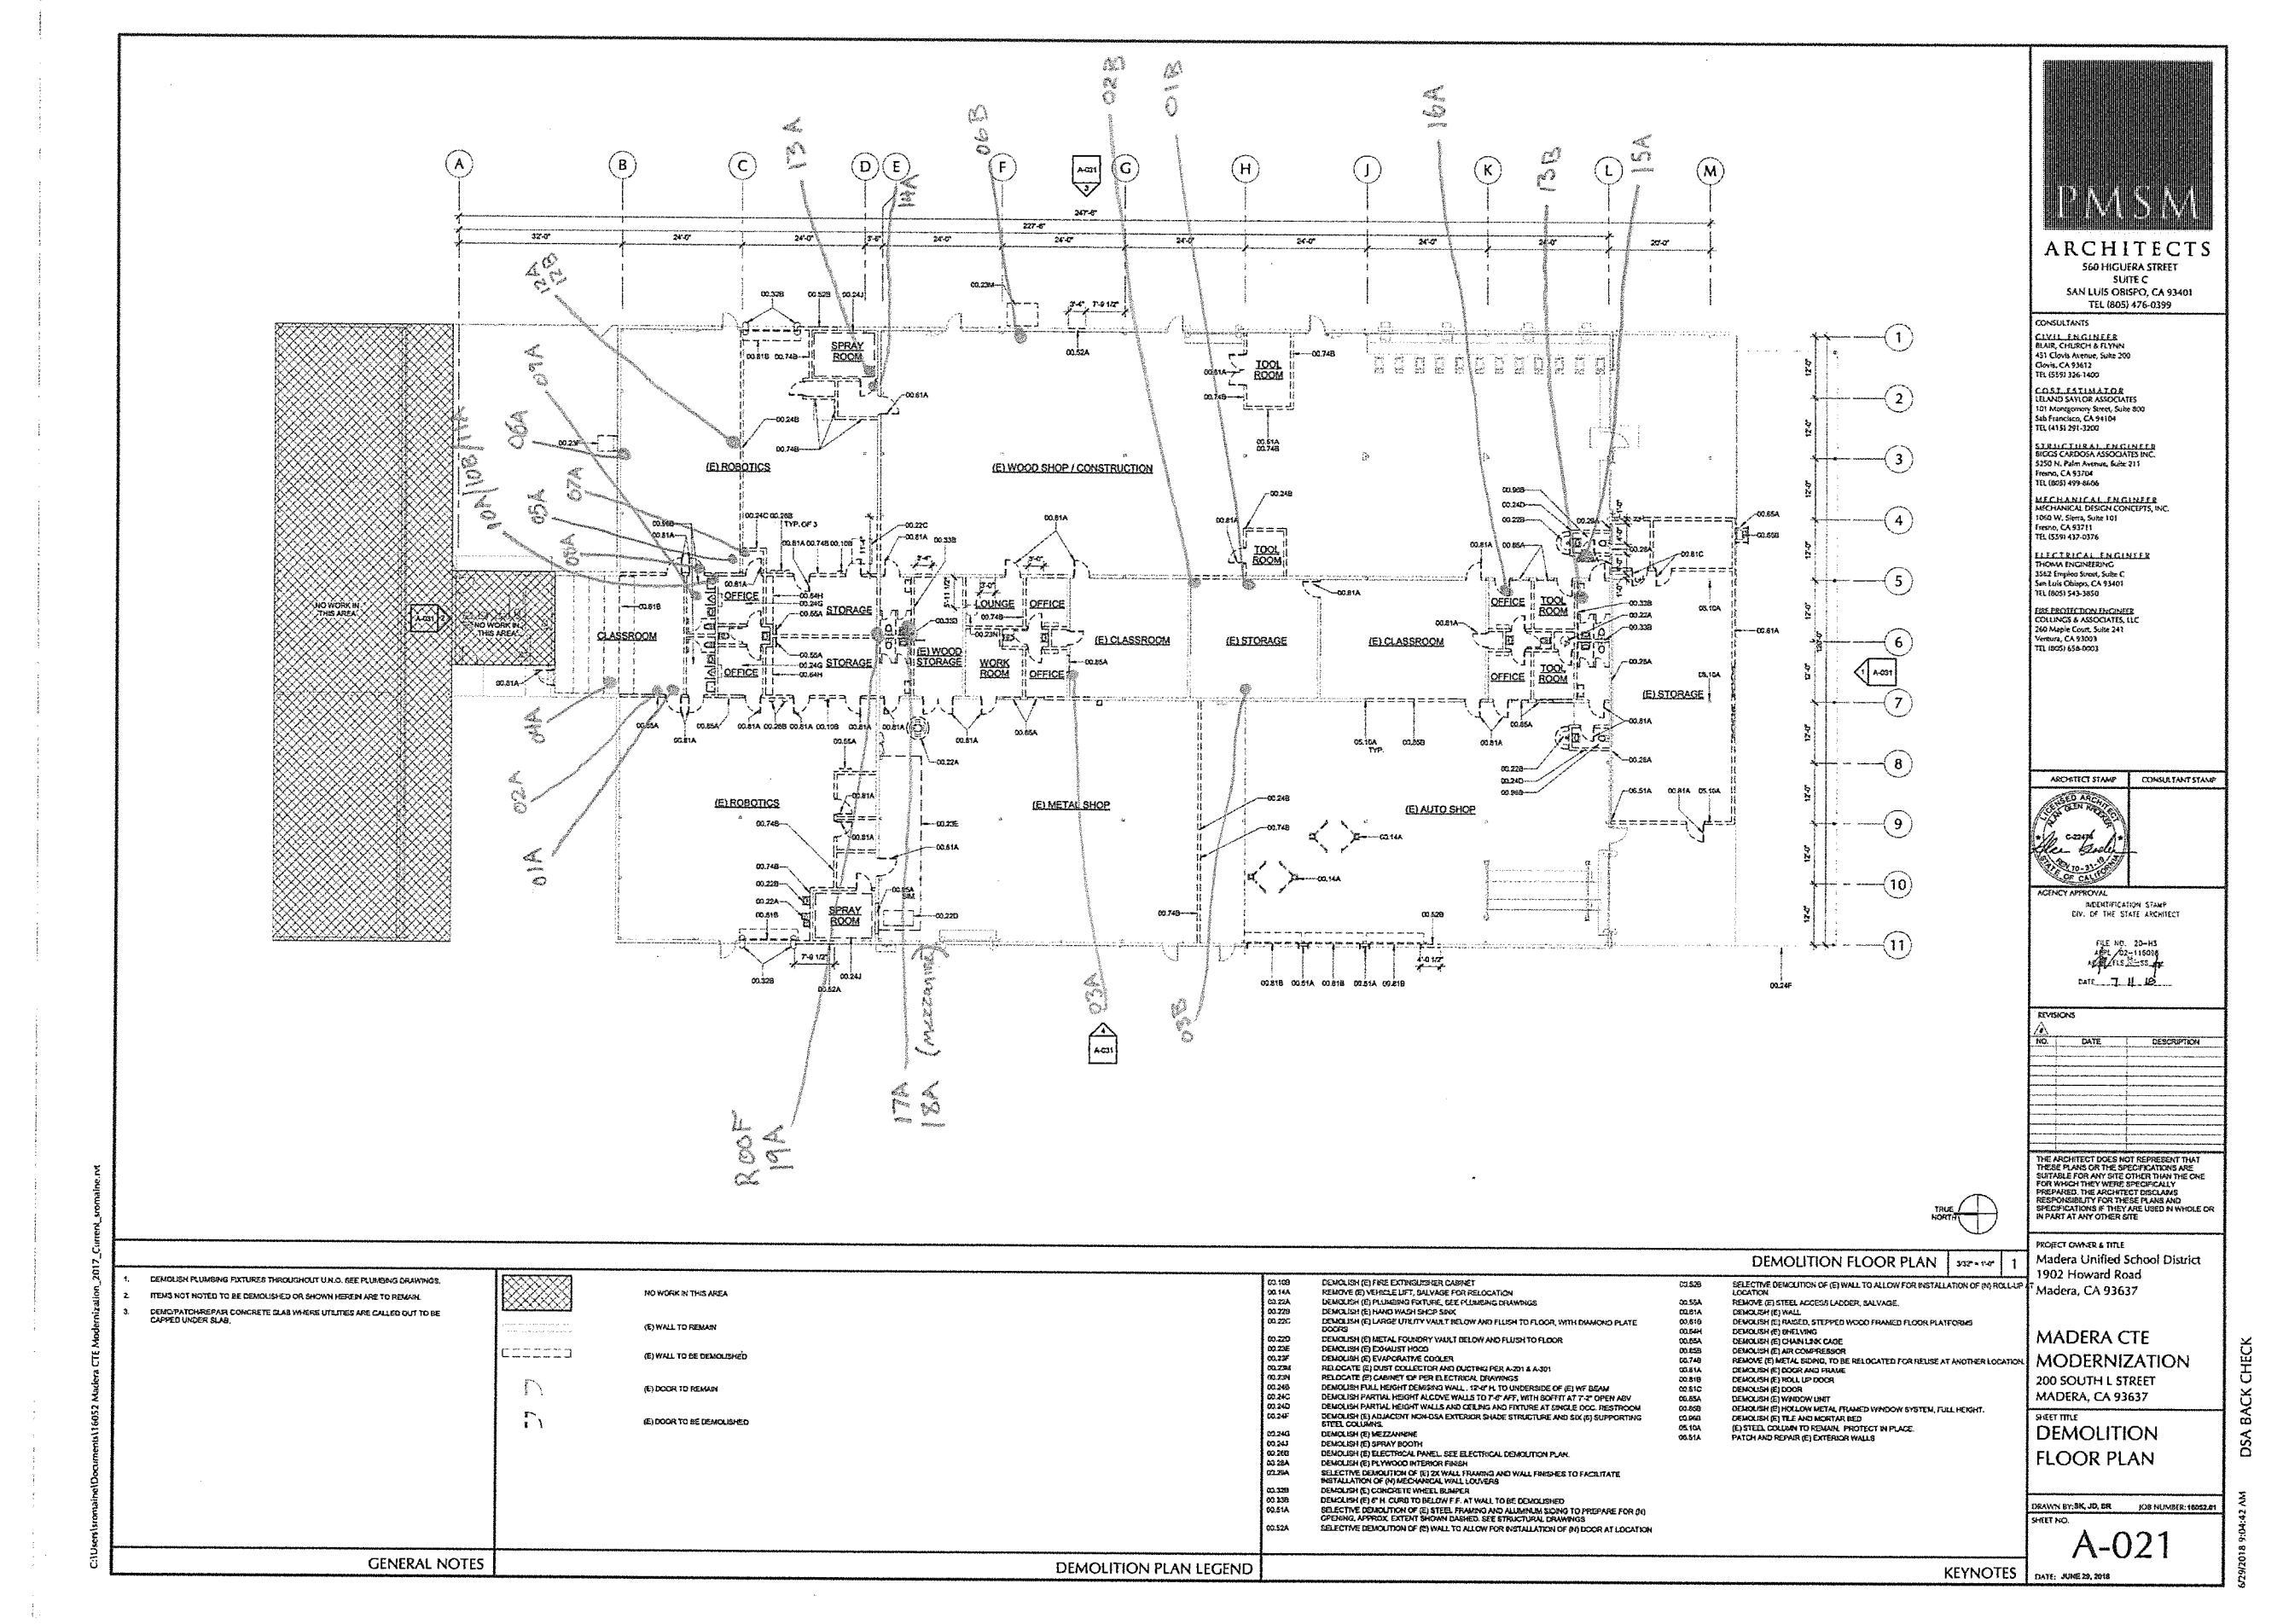
Appendix C Sample Location Drawing

Transite panels at walls in Room 6 (Spray Booth), walls and ceilings in Room 10 and Room 16 (Restrooms), and the west and north walls in Room 21 (Janitor)
